CURRENT AIR PHOTO

1947 HISTORIC AIR PHOTO

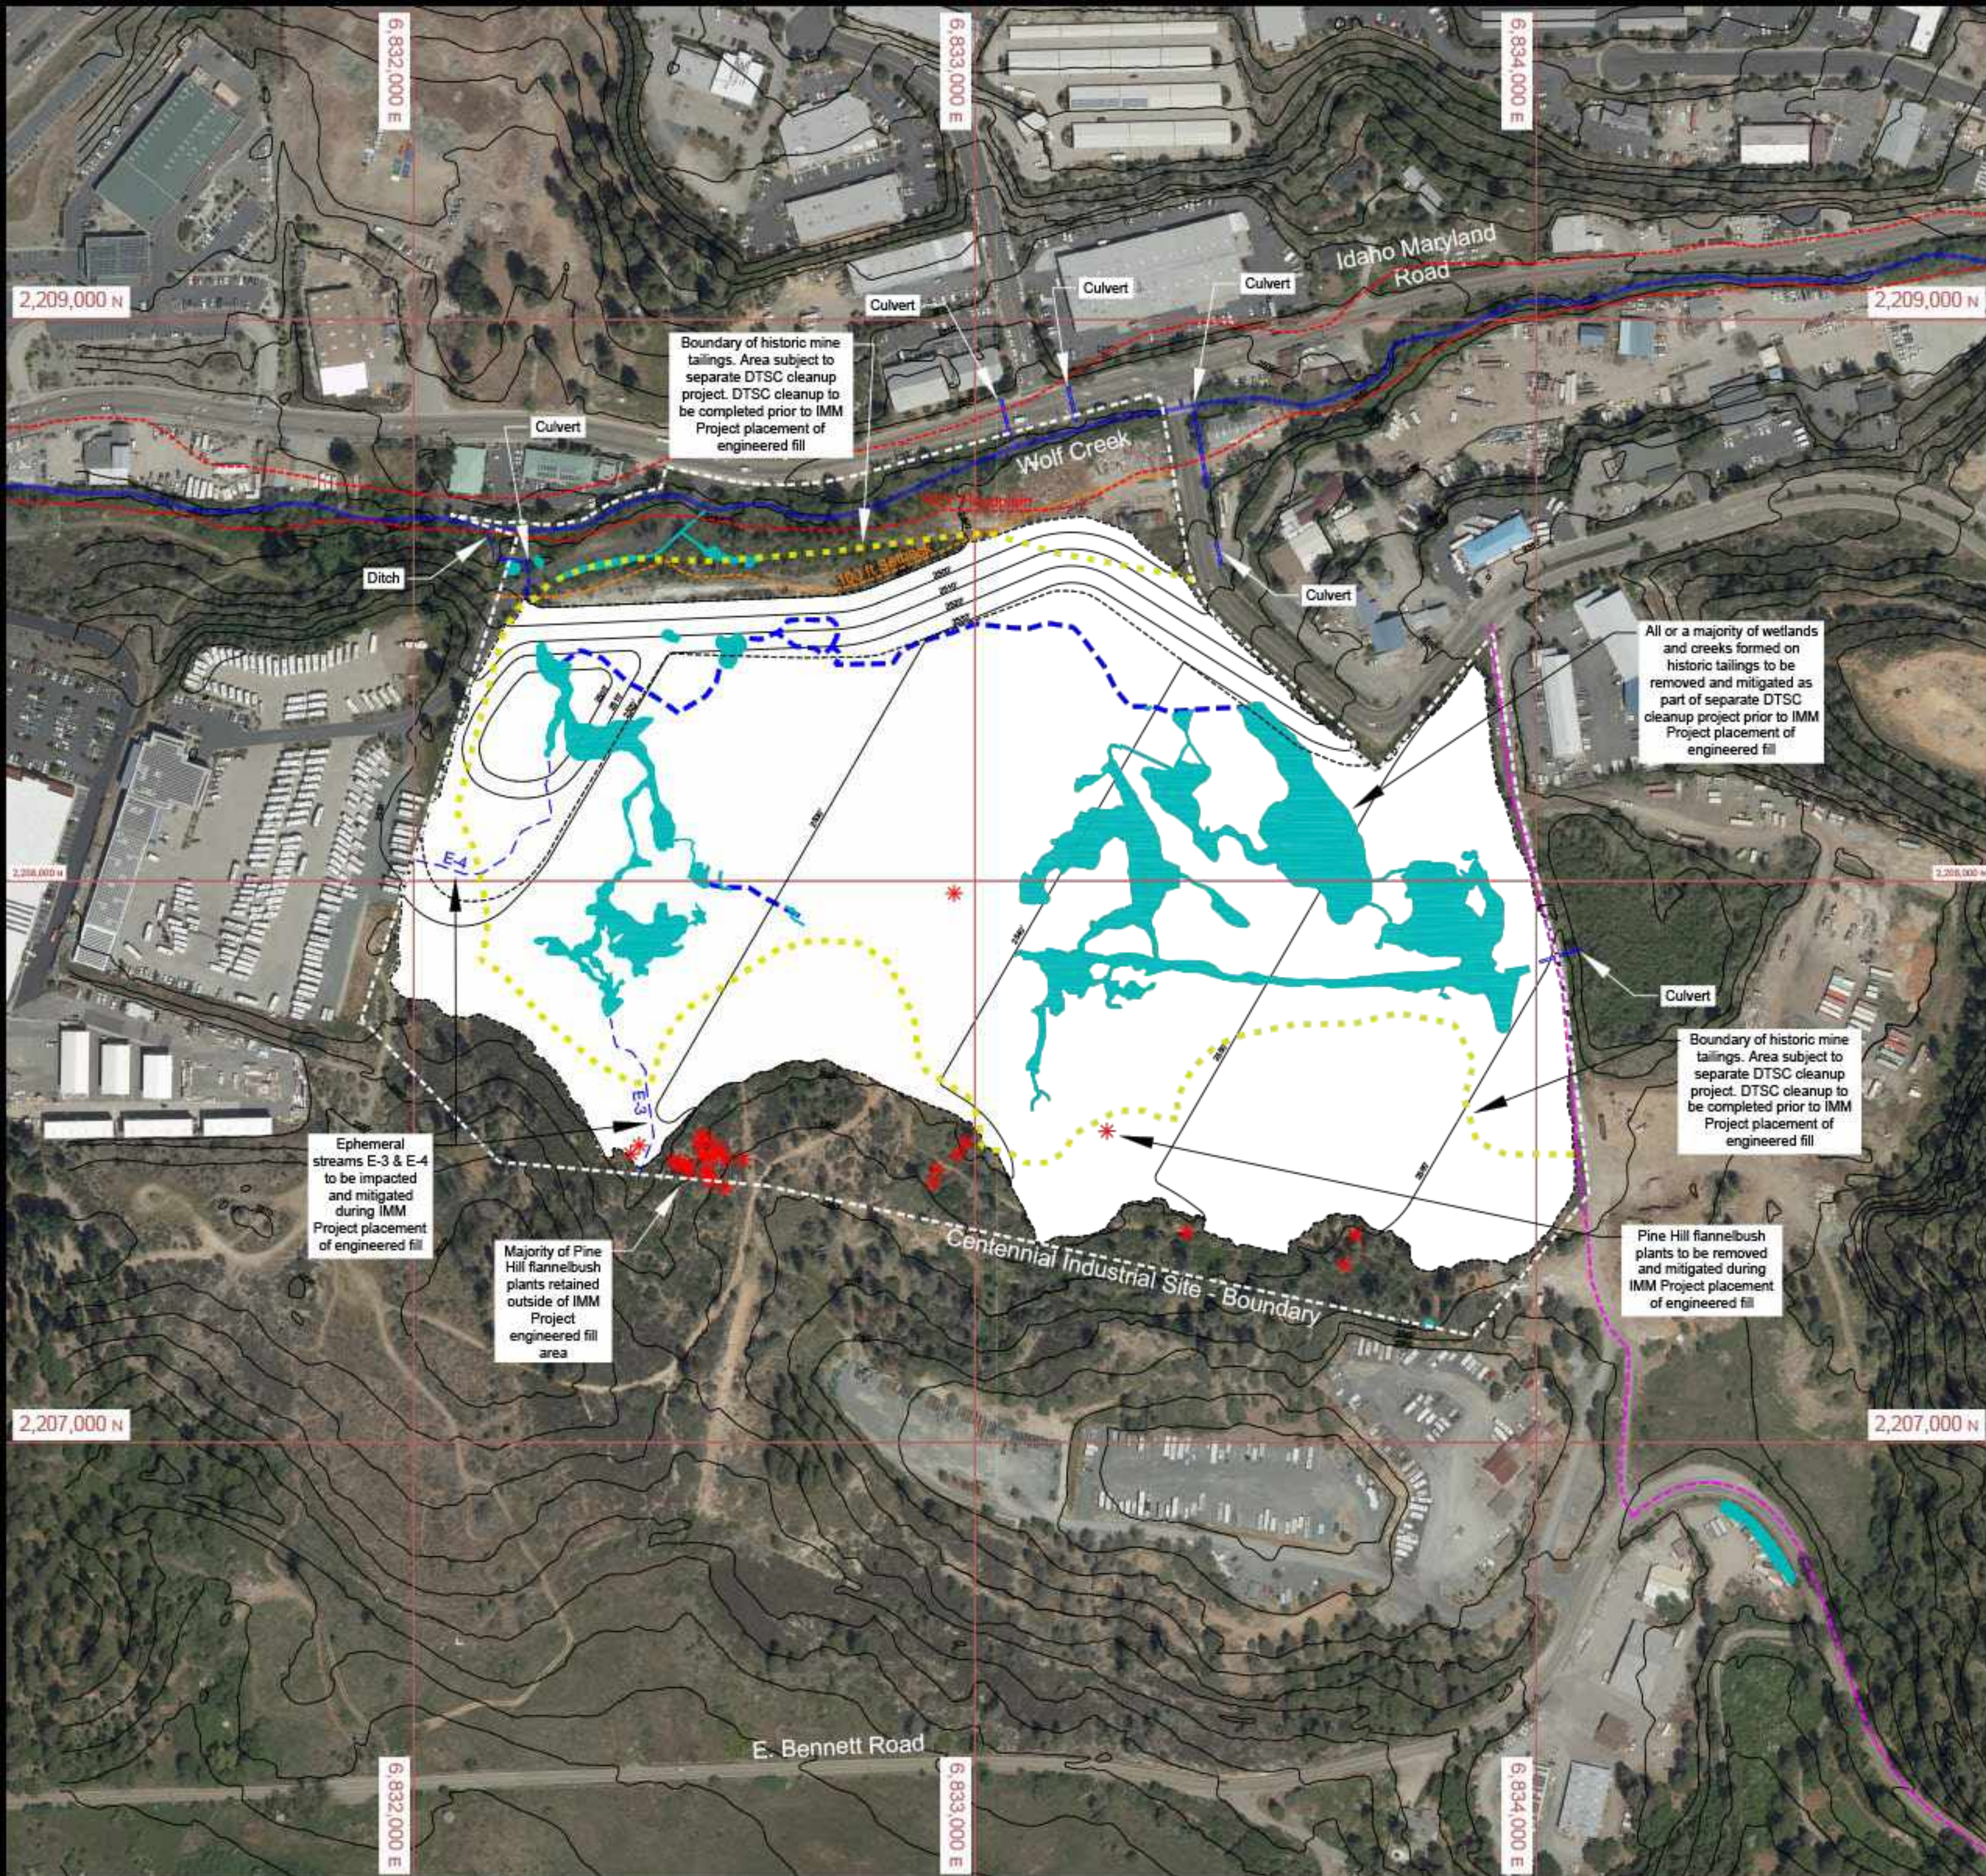
Sensitive resources plotted on map based on reports:
 Centennial Industrial Site
 Biological Resources Assessment
 Greg Matuzak Environmental Consulting LLC, November 2019
 Centennial Industrial Site
 Aquatic Resources Delineation of Water of the United States and State of California
 Greg Matuzak Environmental Consulting LLC, November 2019

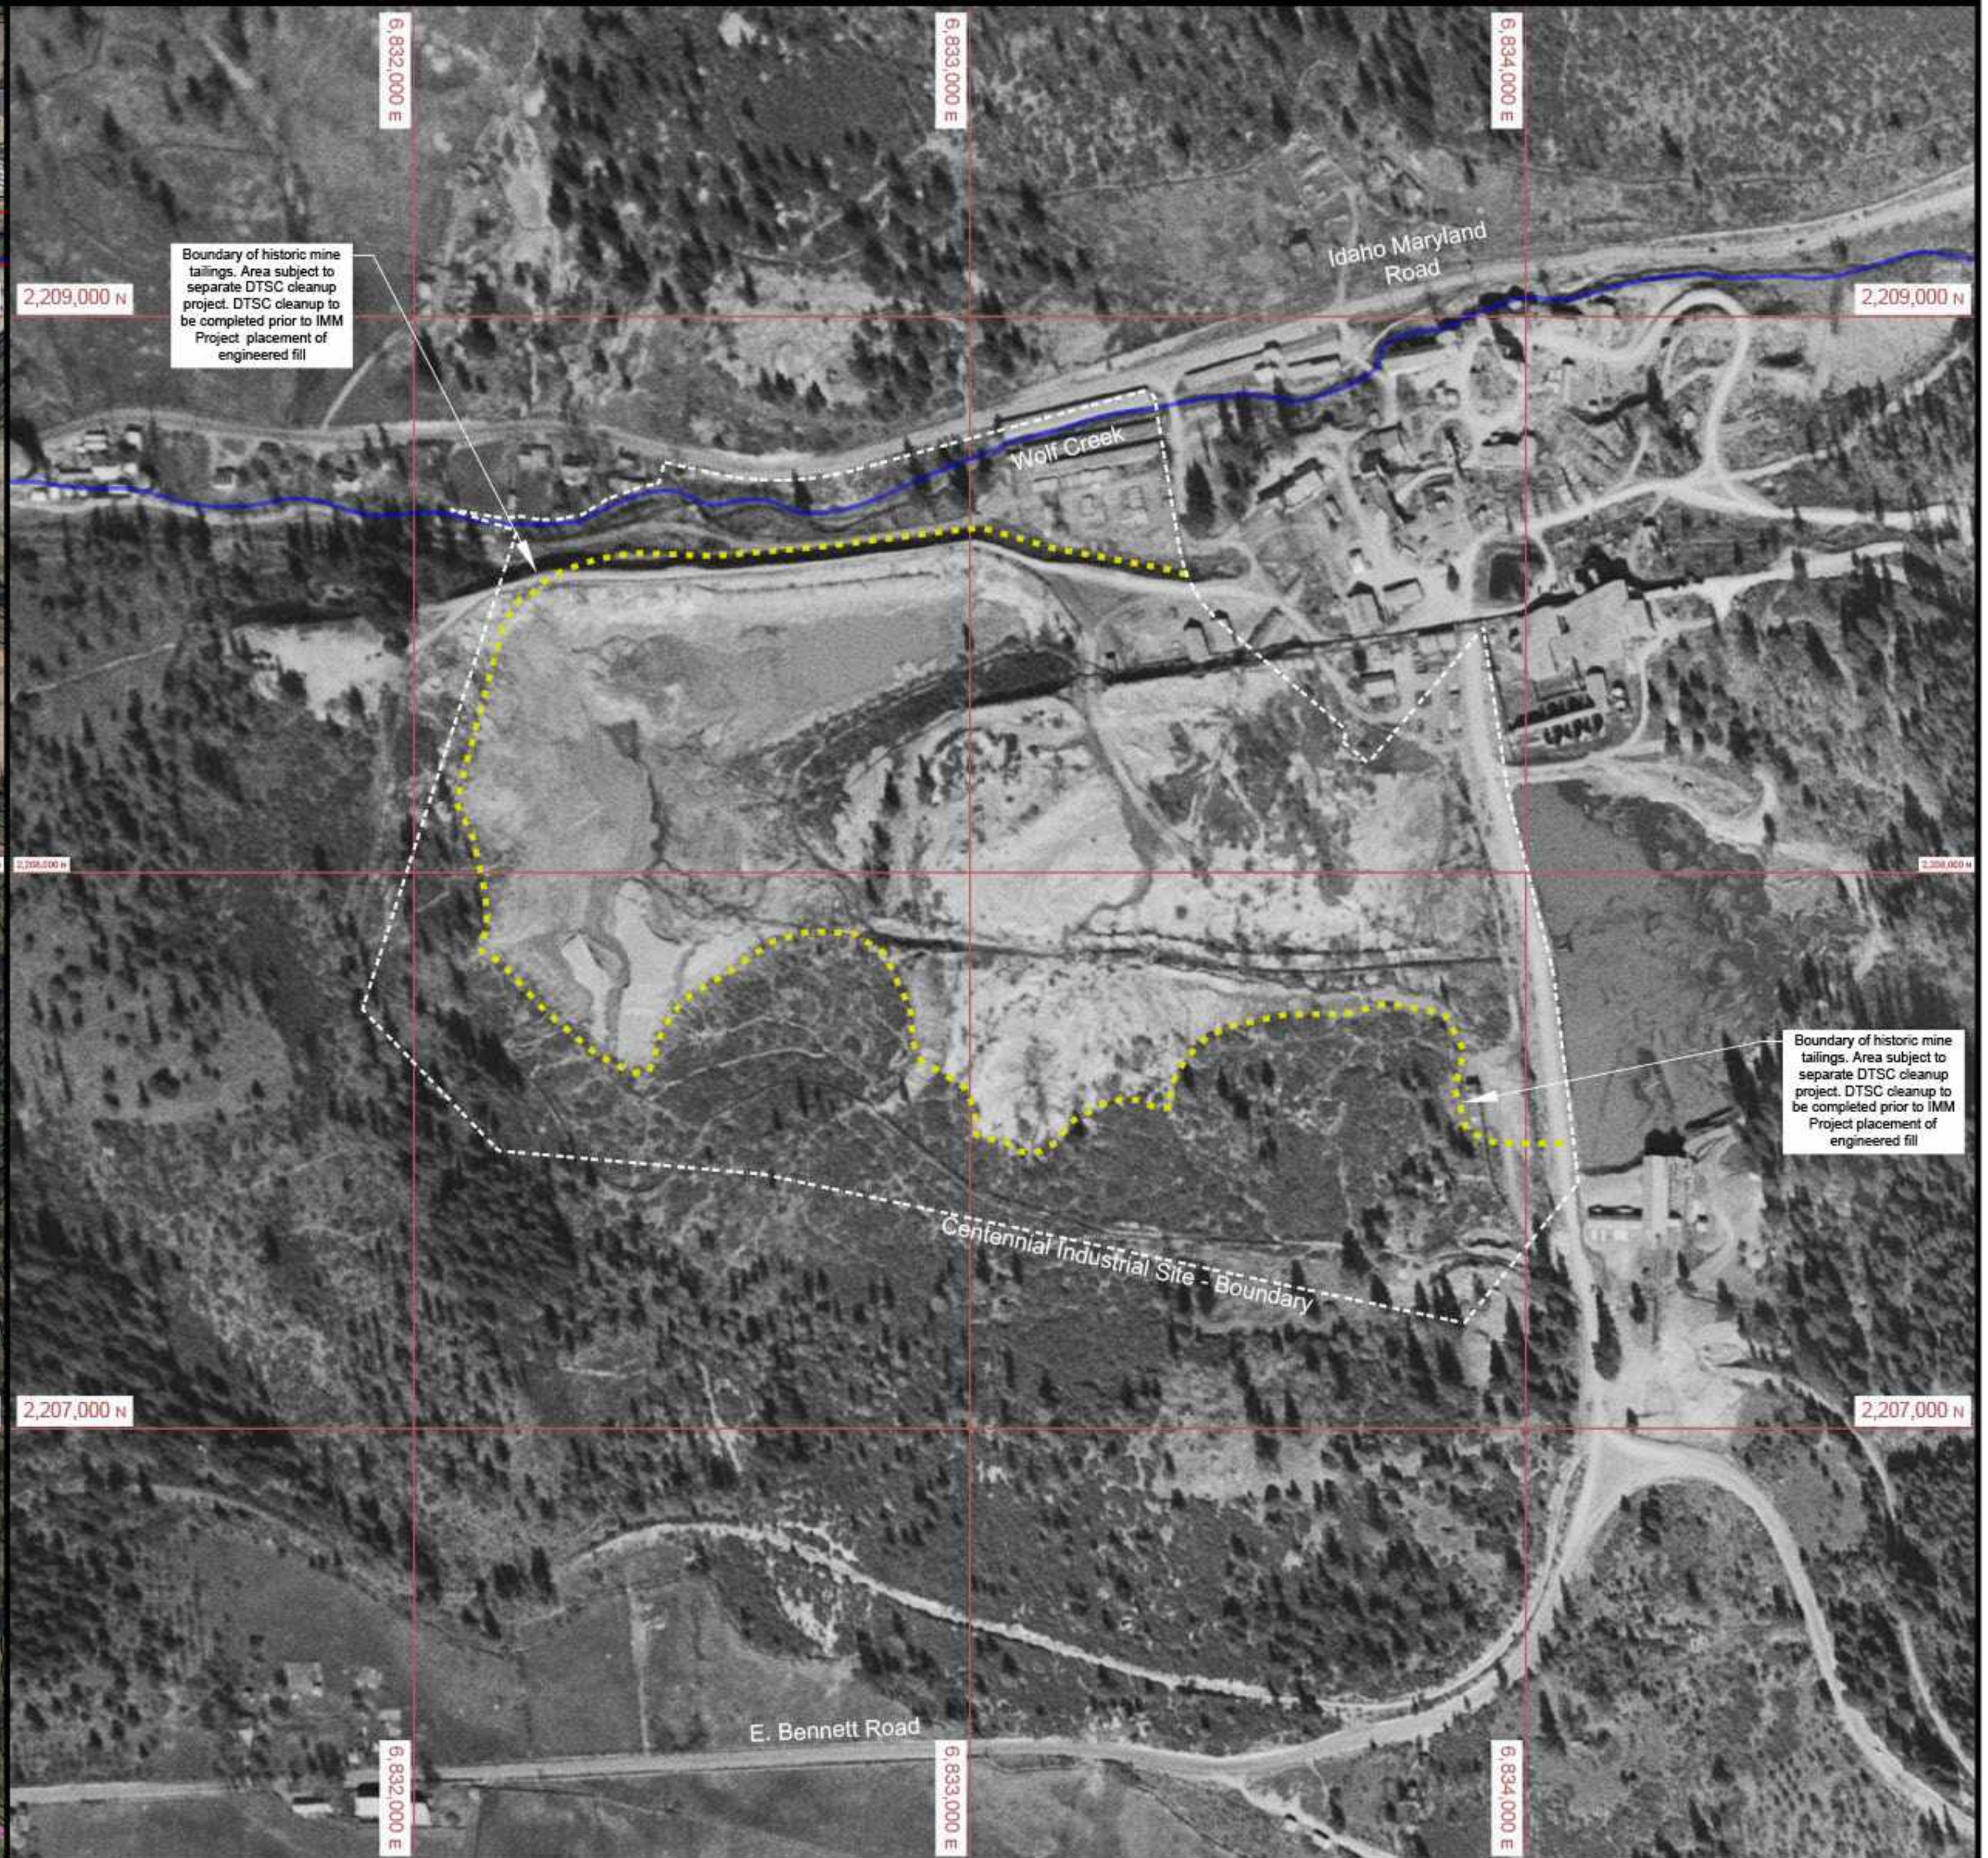
Historic 1947 airphoto taken after WWII mine closure (source USGS).
 Centennial Industrial Site was historic mine tailings site.
 Cleanup of mine tailings area on Centennial site is subject to a separate DTSC clean-up project. DTSC clean-up project will be completed before engineered fill is placed on the site as part of the Idaho-Maryland Mine Project.
 The majority of impacts and mitigation for removal of wetlands and streams which have formed on top of the historic mine tailings site are anticipated to be from the DTSC clean-up project (before the engineered fill is placed from the Idaho-Maryland Mine Project).
 Several Pine Hill flannelbush plants will be impacted by the placement of engineered fill as part of the Idaho-Maryland Mine Project.
